RAILROAD INSPECTION REPORT

RAILROAD TPWRR

LOCATION: Chenoa, IL

DOT/AAR: 802009C

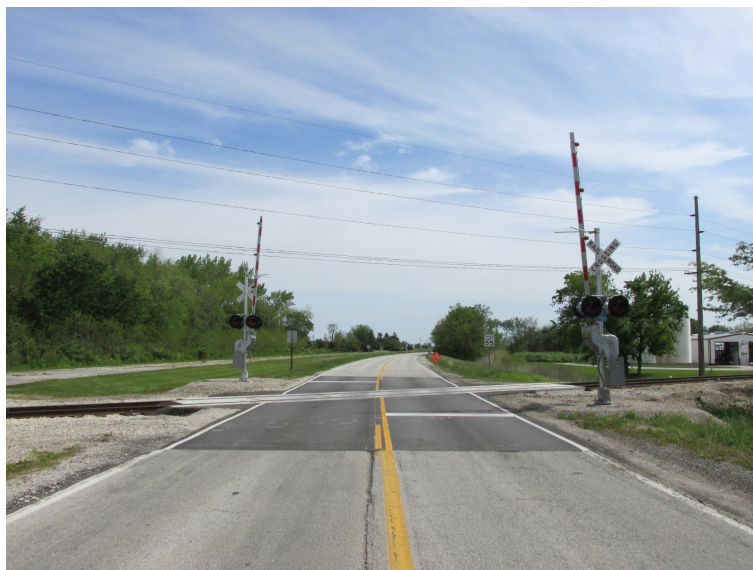
Comments: Signals appear to be in satisfactory operating condition. New XP- 4 controller with recorder in 2016. Signals replaced and gates added in 2016. Prewarn was 10 seconds, reduced to 8 seconds onsite. New relay to be overhauled to reduce the time to 5 seconds or under. North gate foundation could use more rock around the foundation after it settled.
